Manhole Inspection Summary

Manhole # S09WW_019MH

Insp Date: **4/11/07 11:26 AM**

Location Address: **3311 DORCHESTER RD**

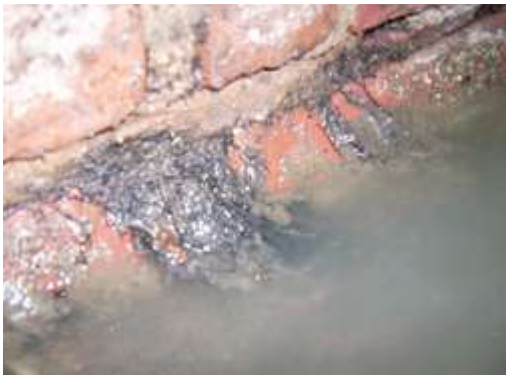
Defect 3

OPPOSITE SIDE OF CHANNEL ROOT INFILTRATION

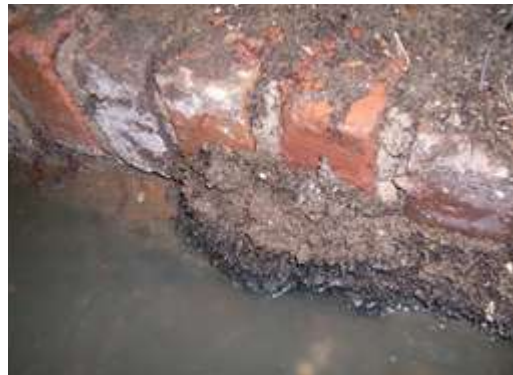
Defect 2

Condition: ☐ Sound ☐ Cracked ☒ **Root Intrusion** ☐ Deteriorated ☐ Leaks ☐ Debris

ROOT INFILTRATION IN CHANNEL

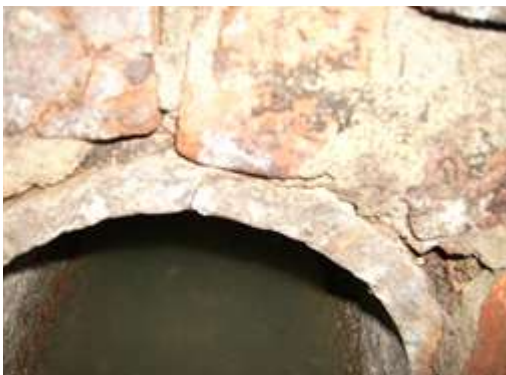
Defect 1

O12 NO SEAL PRESENT

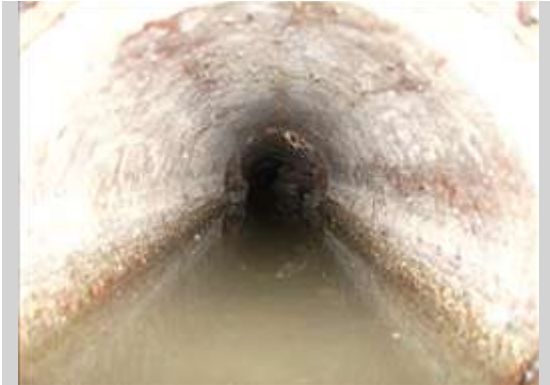
12 O'Clock Outflow

8 in. Circular Gravity Sewer
Pipe Out @ 12 O'Clock

Invert Depth: **7.57** (ft.) Flow Characteristics: **Slow**

Deposits: ☐ None ☐ Mud ☐ Sludge ☒ **Debris** ☐ Grease

Silt Depth: **0.5** (in.) Deposits Extent: **Light**

Infiltration: **None** Pipe Seal Cond: **Unknown**

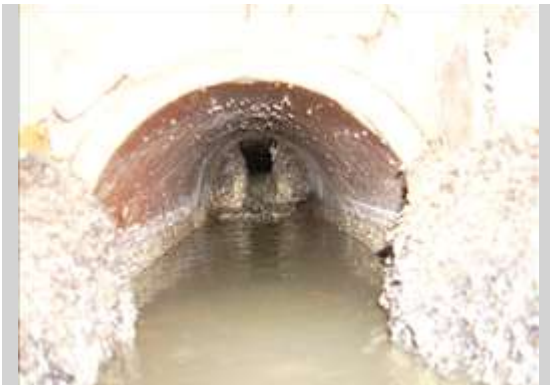
6 O'Clock Inflow

8 in. Circular Gravity Sewer
Pipe In @ 6 O'Clock

Invert Depth: **7.55** (ft.) Flow Characteristics: **Slow**

Deposits: ☐ None ☐ Mud ☐ Sludge ☒ **Debris** ☐ Grease

Silt Depth: **0.5** (in.) Deposits Extent: **Light**

Infiltration: **None** Pipe Seal Cond: **Sound**
